Docket No. 217 - Development and Management Plan Inspection

Northeast Utilities Service Company Certificate of Environmental Compatibility and Public Need for the construction of a 345-kV electric transmission line and reconstruction of an existing 115-kV electric transmission line between Connecticut Light and Power Company's Plumtree Substation in Bethel, through the towns of Redding, Weston, and Wilton, and to the Norwalk Substation in Norwalk, Connecticut.

Date: December 22, 2005

Location: 345kV XLPE Component

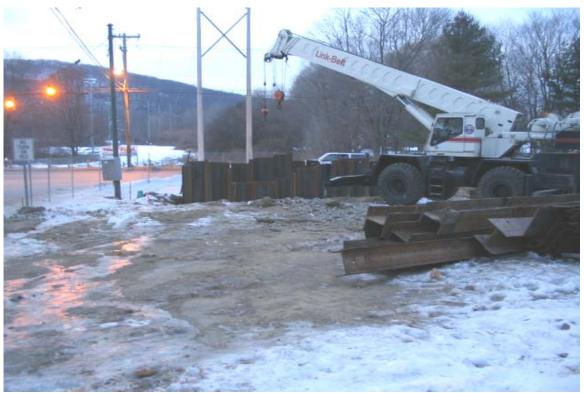
345kV XLPE (Jack and Bore): Overall view of the site with excavation underway and continued work on the bore pit. 12/22/05

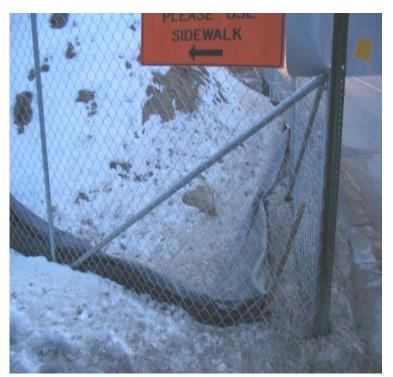
Various views of the snow covered stockpile on site.

Photo on the left shows where the silt fence appears to be sagging slightly and may need some repair prior to snow melt. 12/22/05
